# An 1834 William IV Sixpence with a Laboratory-Confirmed Multi-Strike Mint Error from the Steam Press Era

*A. Ikraam*

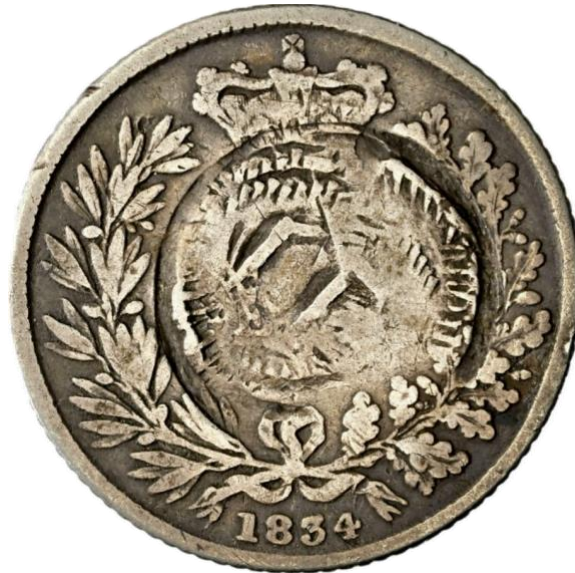
Figure 1. The 1834 William IV Sixpence showing reverse deformation.

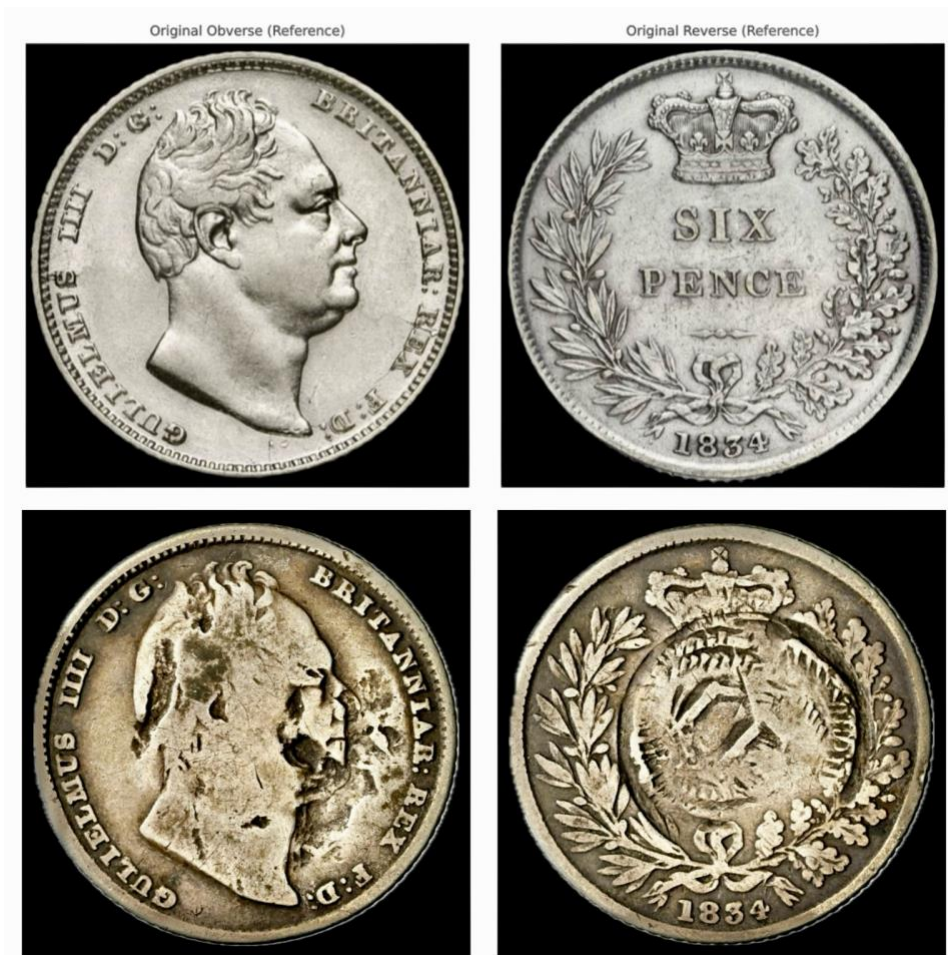
The obverse shows extensive deformation consistent with repeated in-die striking. Optical profilometry of the portrait centre recorded relief variation of approximately 40–790  $\mu\text{m}$  ( $S_z \approx 750 \mu\text{m}$ ). Arcuate troughs, terrace-like steps, and raised shoulders were observed, with steep localised slopes. These features are diagnostic of in-die metal displacement under repeated compression and are incompatible with post-mint abrasion or flattening.

Figure 2. Reference specimens (top) versus the present coin (bottom), showing obverse and reverse anomalies.

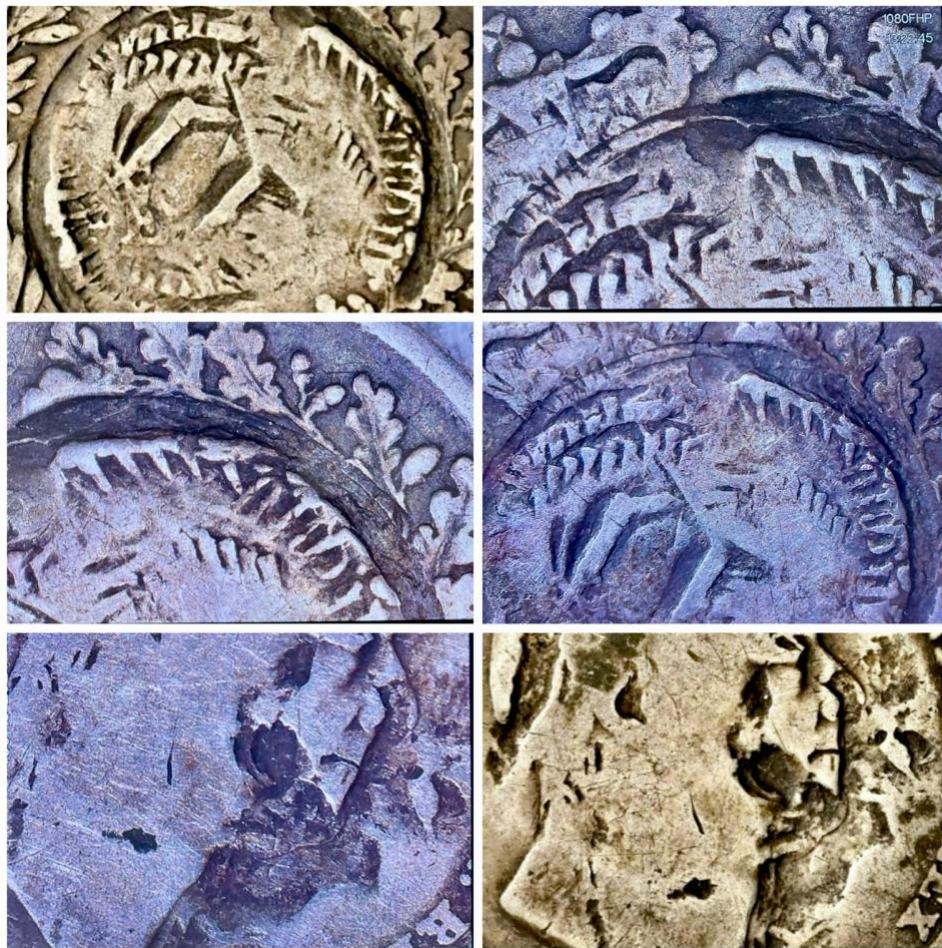
- The word SIXPENCE is almost entirely effaced, with faint traces of “PE” surviving.
- A domed, terraced surface occupies the central field, formed by overlapping strikes.
- A shallow central depression (c. 200  $\mu\text{m}$ ) contains a concentric “ghost ring”, marking the obstruction’s outline.
- Radiating metal-flow lines indicate dynamic metal displacement during successive blows.

Together with the preserved natural silver patina, these features confirm a genuine mint-stage origin.

Figure 3. Close-up diagnostic imaging of both obverse and reverse anomalies under varied lighting and magnification.

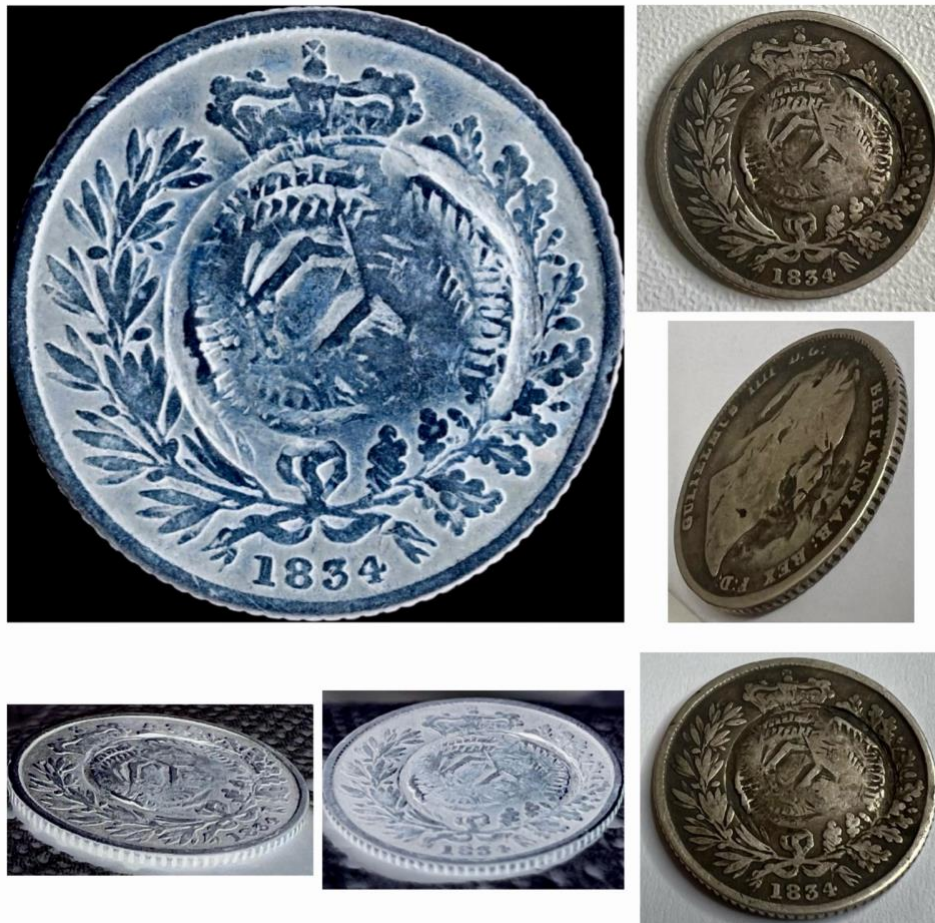
Figure 4. Multi-angle photographic grid under different lighting perspectives.

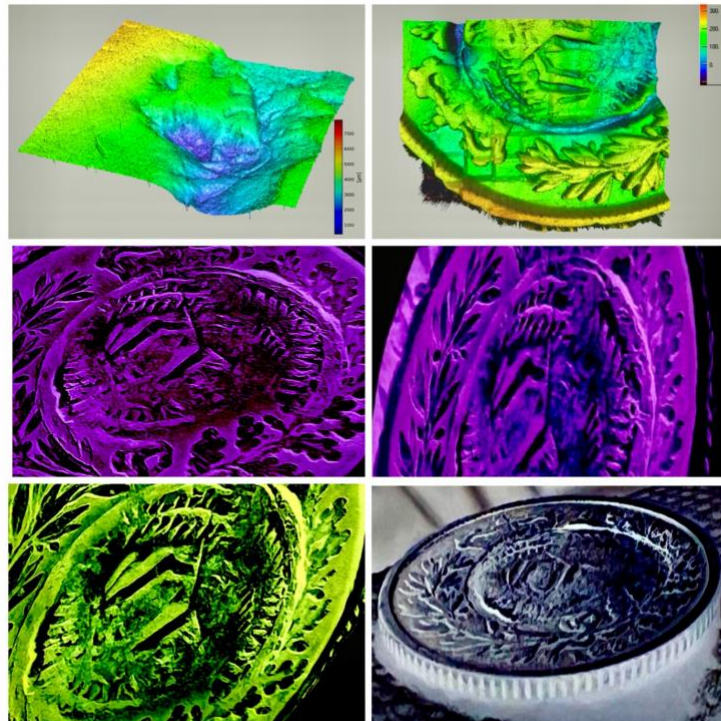
Figure 5. False-colour profilometry maps showing relief variation & overlapping error strikes

The combined evidence supports classification of this coin as a severe multi-strike mint error, exhibiting characteristics of a retained die cap with elements of a late-stage brockage and strike-through obstruction. To the best of the author's knowledge, no comparable example has been recorded in published numismatic archives to date.
