# XRF Analysis of Coins in Slabs etc

Gary Oddie

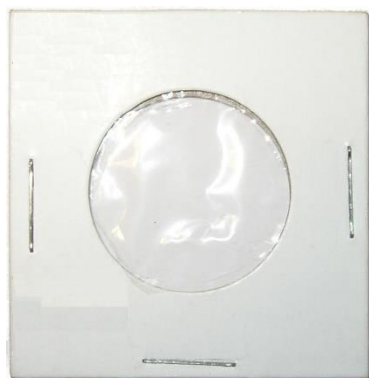
Mylar flip – 0.015mm

Along with a reference measurement, in air, four different plastics were tested: (1) Mylar lined coin flip, (2) PVC bag, (3) PVC flip, and (4) a slab. The slab appears to be made from polycarbonate rather than acrylic. The plastics are illustrated below, along with a measurement of the thickness of a single layer of the material.

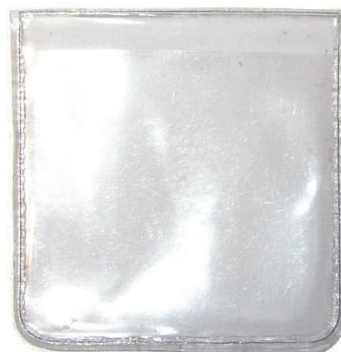
PVC Flip – 0.14mm

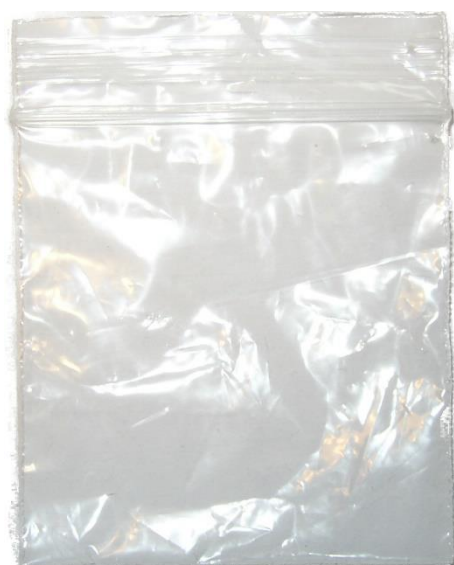
PVC Bag – 0.025mm

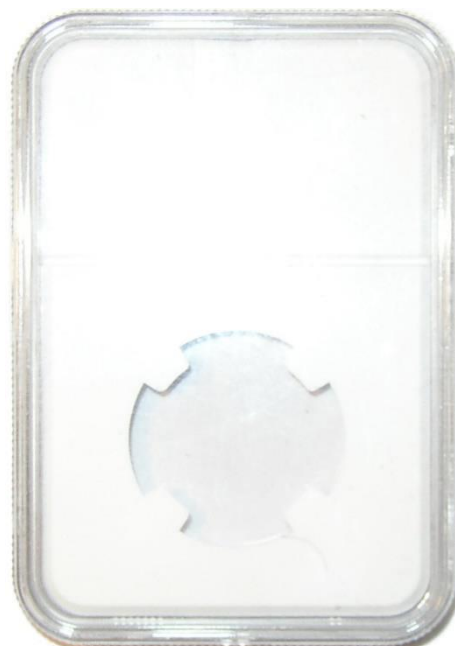
Slab – 1.66mm

Thus making an XRF measurement through a slab gives almost random compositions. This is due to the way the built-in interpretation software tries to make a best fit to the X-ray spectrum coming back into the machine and scales the composition to give a total of 100%. The presence of a thick enough layer of plastic causes sufficient attenuation to cause the machine to fail to make a proper reading of the metal below, in some cases finding totally the wrong metal.
